NEWSLETTER

Volume 19 No 4
August 2006

A Summary of Earthquakes in 2005

David Galloway presents a summary of seismic activity in 2005

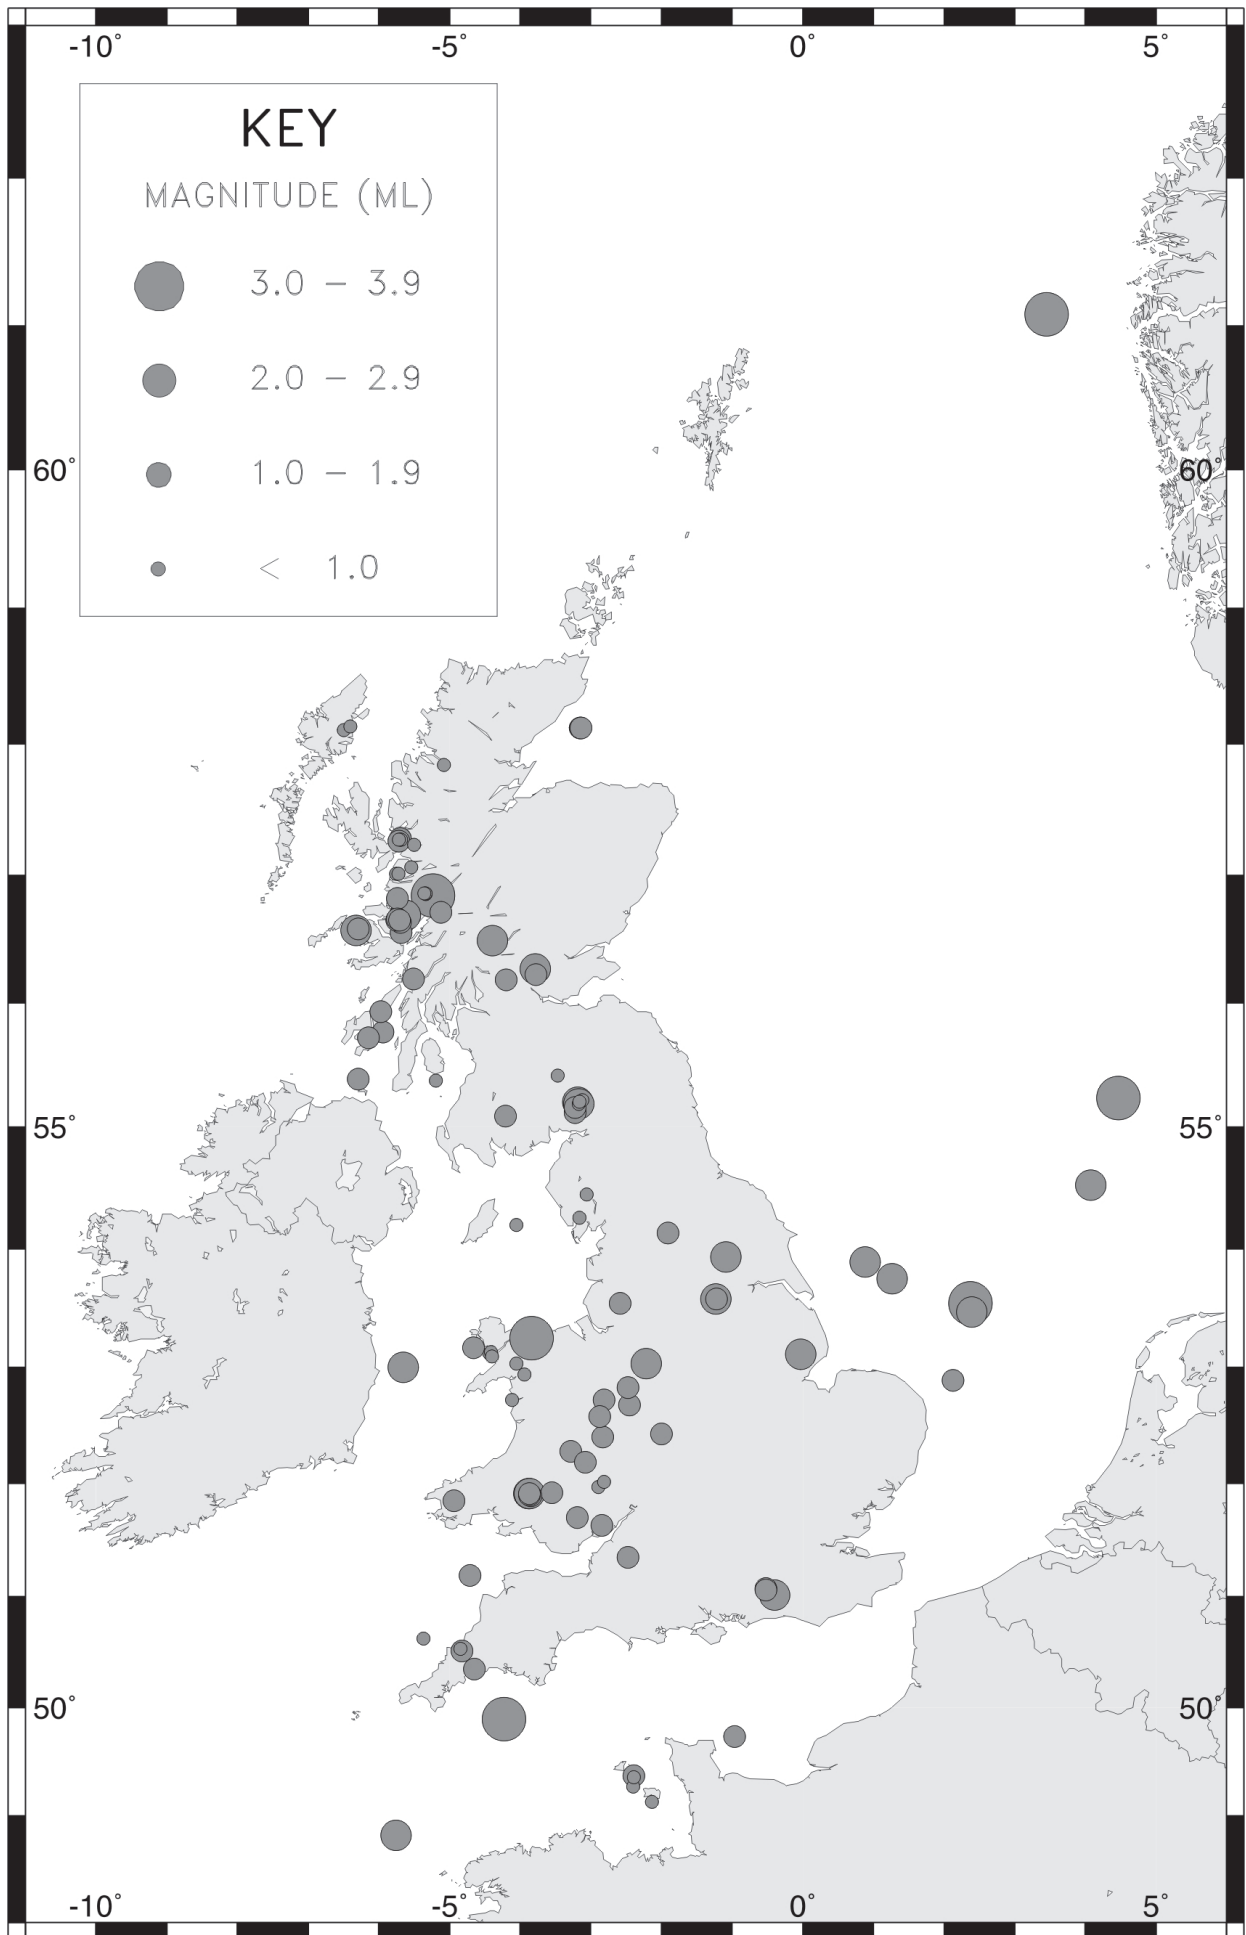
Figure 2. Epicentres of all UK earthquakes located in 2005 (from the Bulletin of British Earthquakes 2005).

There were 112 earthquakes in the UK region which were located by the monitoring network during the year (Figure 2), with 27 having magnitudes of 2.0 ML or greater and six having magnitudes of 3.0 ML or greater. Twelve of the events with a magnitude of 2.0 ML or greater were reported felt, together with a further three smaller ones, bringing the total to fifteen felt earthquakes in 2005.

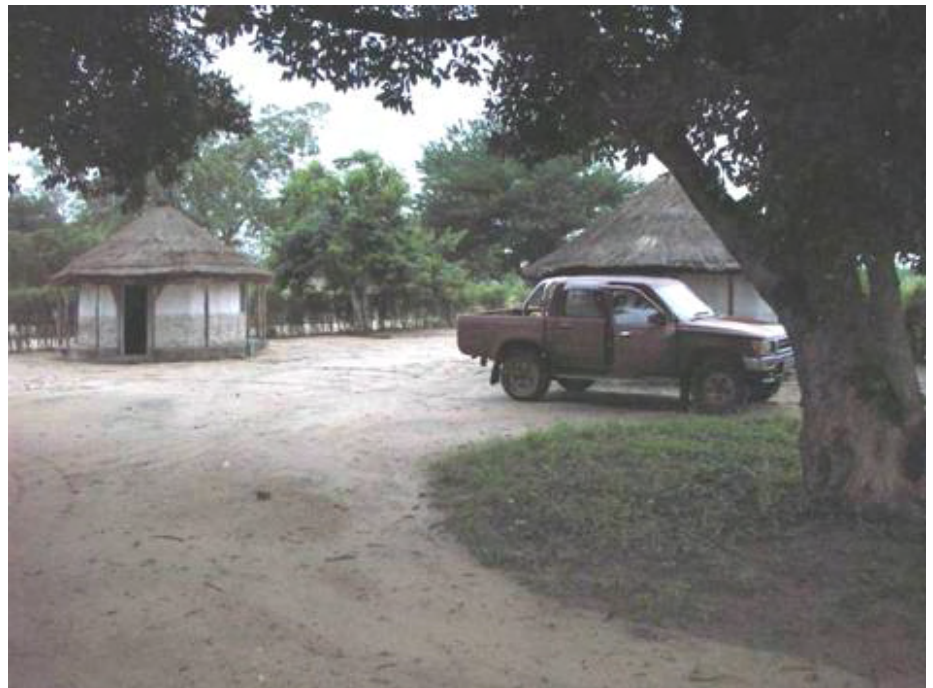
Figure 1 Our accommodation in Chitobe. Located about 30 km from the fault rupture, these traditional dwellings were completely undamaged by the earthquake.

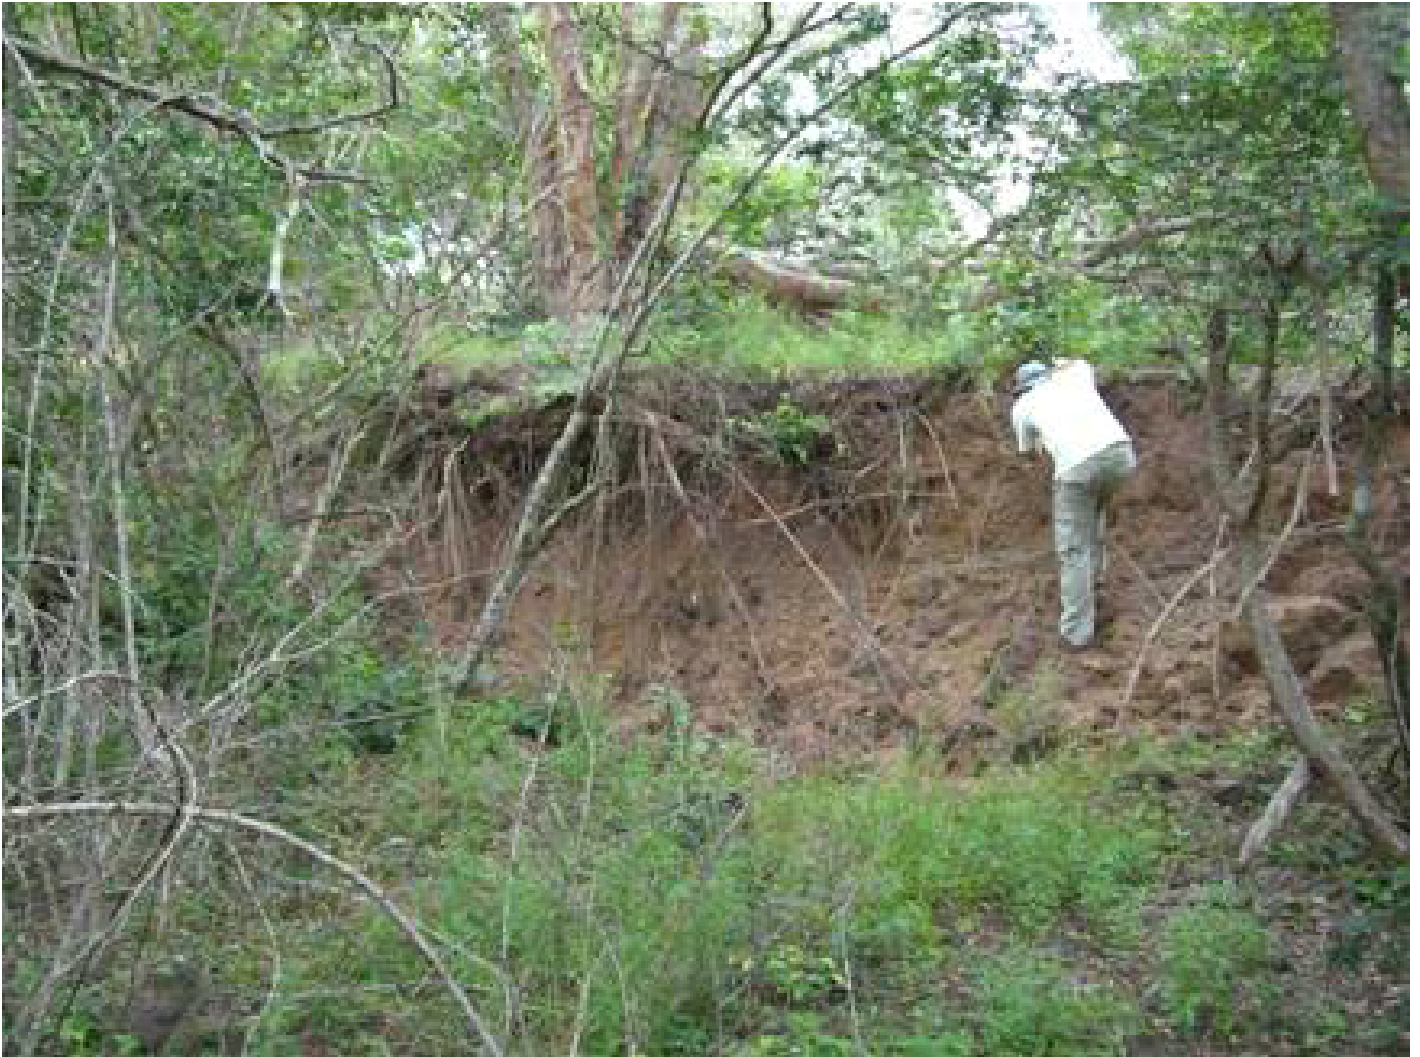
Figure 3 Clark measuring total offset on the fault at the location of maximum slip.

The next morning we met the district administrator Senhora Alice Tamele, whose hospitality and interest in our work were very encouraging. As a result of our meeting, we picked up the fourth member of our field team, a local health worker called Pita Dom Carlos Toalha. Pita proved to be invaluable to us, knowing the local area like the back of his hand and having already visited the locations where locals had informed him of large cracks in ground. By mid-morning we were at the surface rupture (Figure 2), taking photographs, GPS readings and measuring displacements and the orientation of the fault traces. We followed the rupture a short distance to the north, finding a vertical offset of more than 2 metres at one location (Figure 3), and then followed it south – until warned by Pita to stop mapping

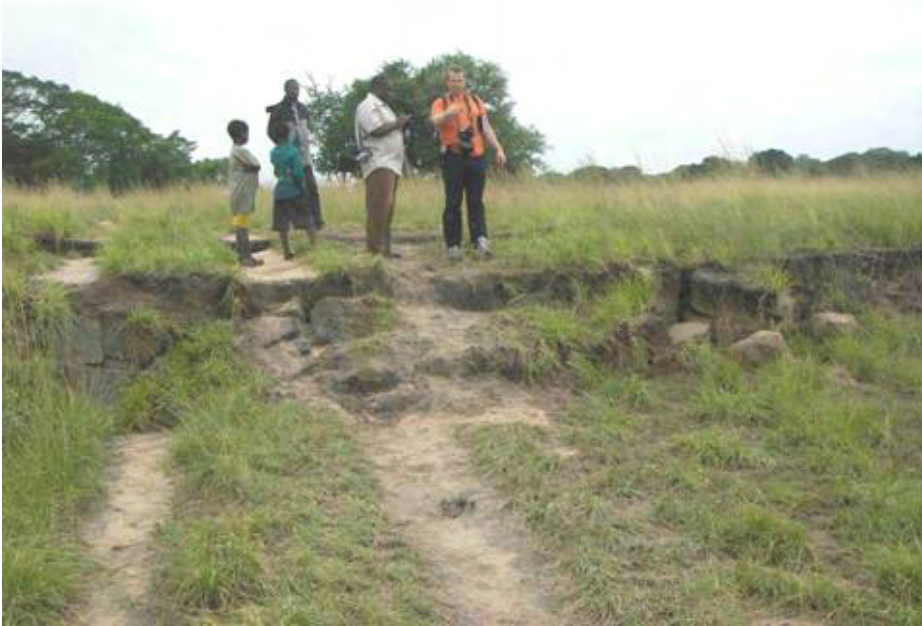
Figure 4 Evidence of left-lateral slip on the fault as well as normal offset.

The strike of the fault rupture was measured NNW, dipping steeply to the west and displaying predominantly normal displacement, with a small component (clearly visible in only one location where the rupture had

displaced tracks, Figure 4) of left-lateral strike-slip, consistent with the Harvard CMT solution for the earthquake. Having established subsequently that the fault was previously unmapped, we had the privilege of being able to baptize this seismogenic structure, opting, in the absence of any prominent geographical feature or settlement in its immediate vicinity, for the Machaze fault.

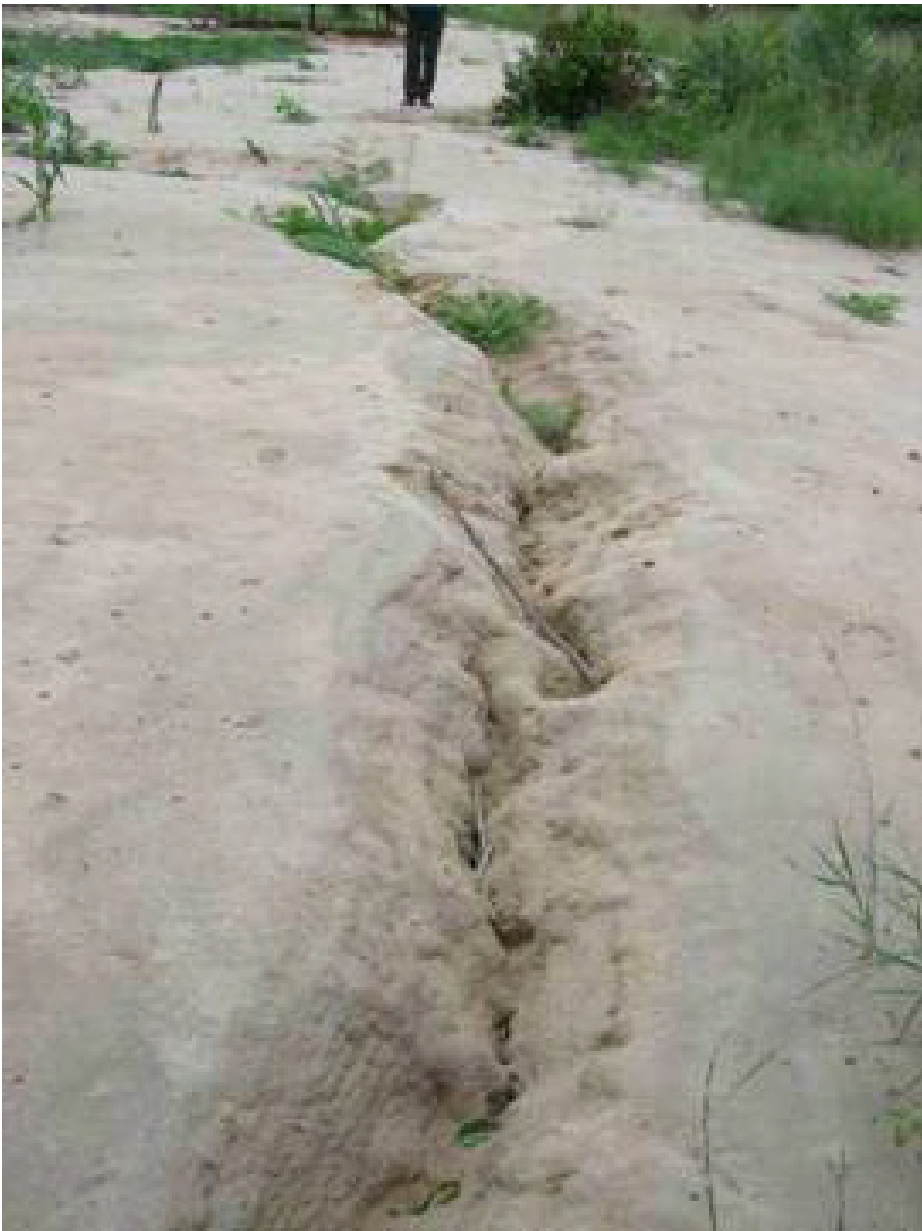
Figure 5 Liquefaction fissure.

Evidence of liquefaction was widespread along the fault rupture, with sand blows and large fissures (Figure 5) surrounded by several metres of ejected sand which was more than half a metre thick in places (Figure 6).

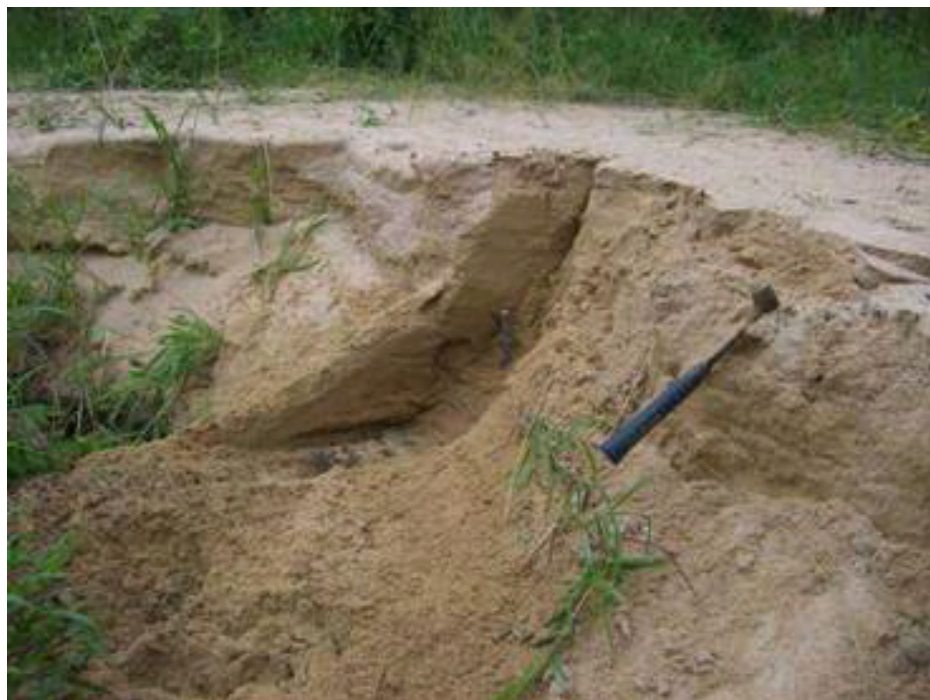
Figure 6 Cutting through liquefied material exposing more than 0.5 m of ejected sand above the original ground surface.

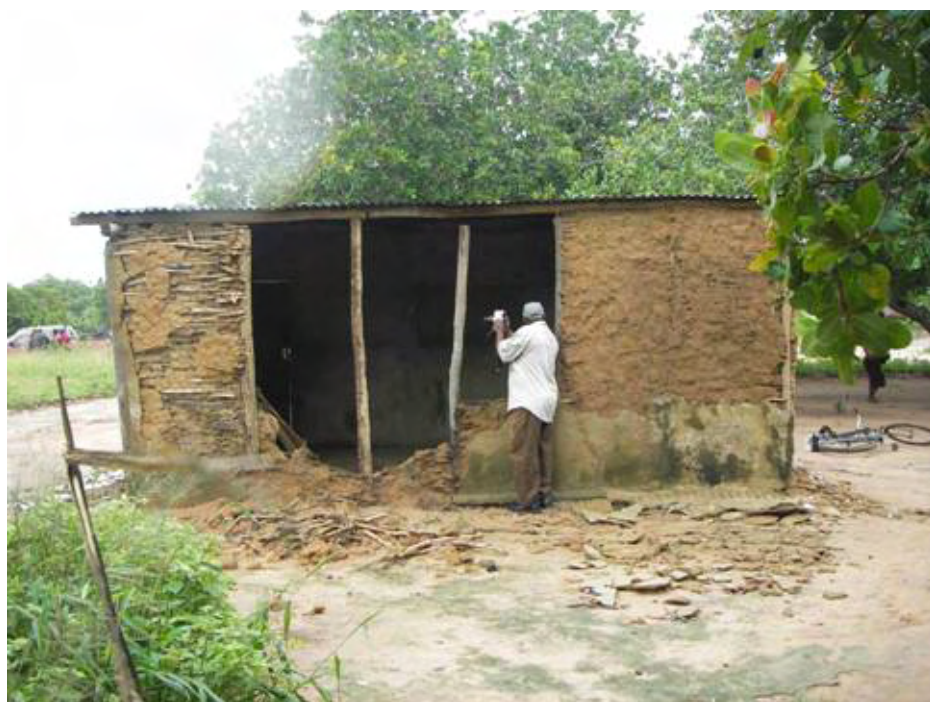
Figure 7 Partial collapse of a badly deteriorated wattle-and-daub dwelling. Most houses constructed from this material performed very well in the earthquake.

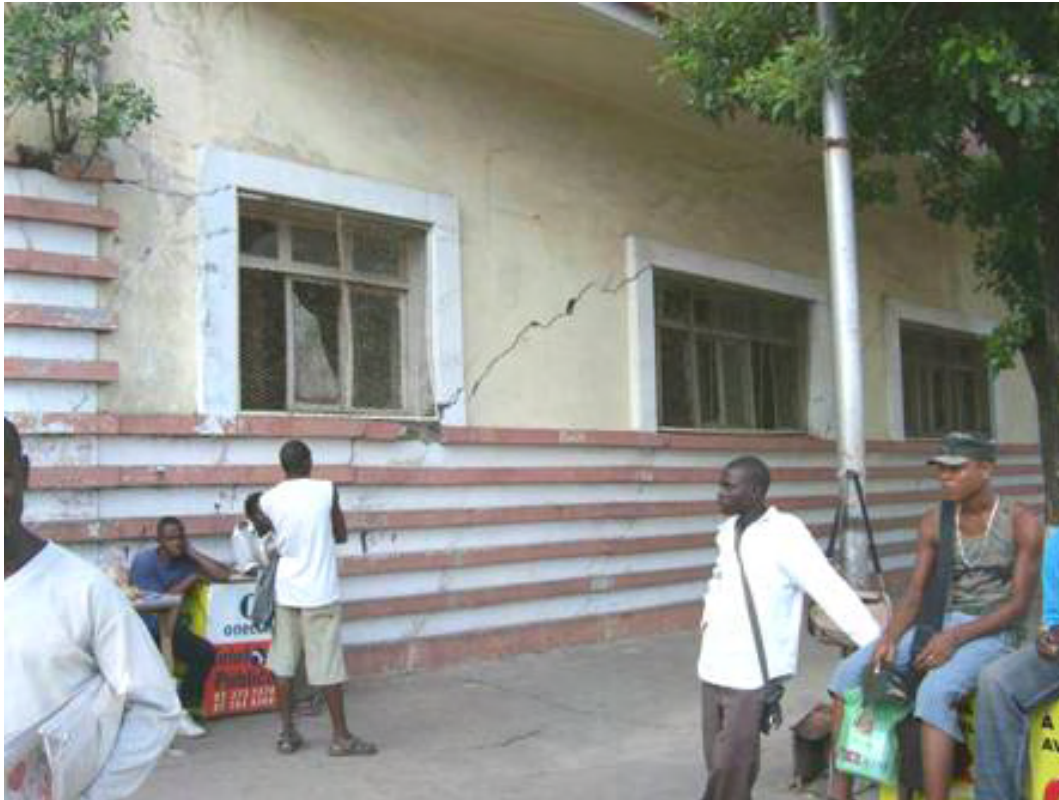
Figure 8 Major shear crack in a building in Beira, more than 200 km from the epicentre.

Earthquake damage? We were informed by locals that these cracks had existed for a long time.

press – were referring to the event as the Espungabera earthquake, citing this town on the border with Zimbabwe as the location of the epicentre and the main concentration of damage. We did not travel to Espungabera, but given that it is located at a significant distance from the causative fault rupture (greater than the distance to Chitobe where the only important damage was the collapse of a heavy water tank perched on four poorly reinforced concrete columns without footings), we suspect that damage there will not have been particularly significant. We also read, again in the Mozambican press, of damage to structures in Beira. On our return to that city, our enquiries on this point were met with amusement; we were told that most buildings in Beira have cracks, some of them significant. We travelled around the city for a while and found this to be true, but locals informed us that all of these cracks (which are probably due to differential settlement – Figure 8) existed long before the earthquake!

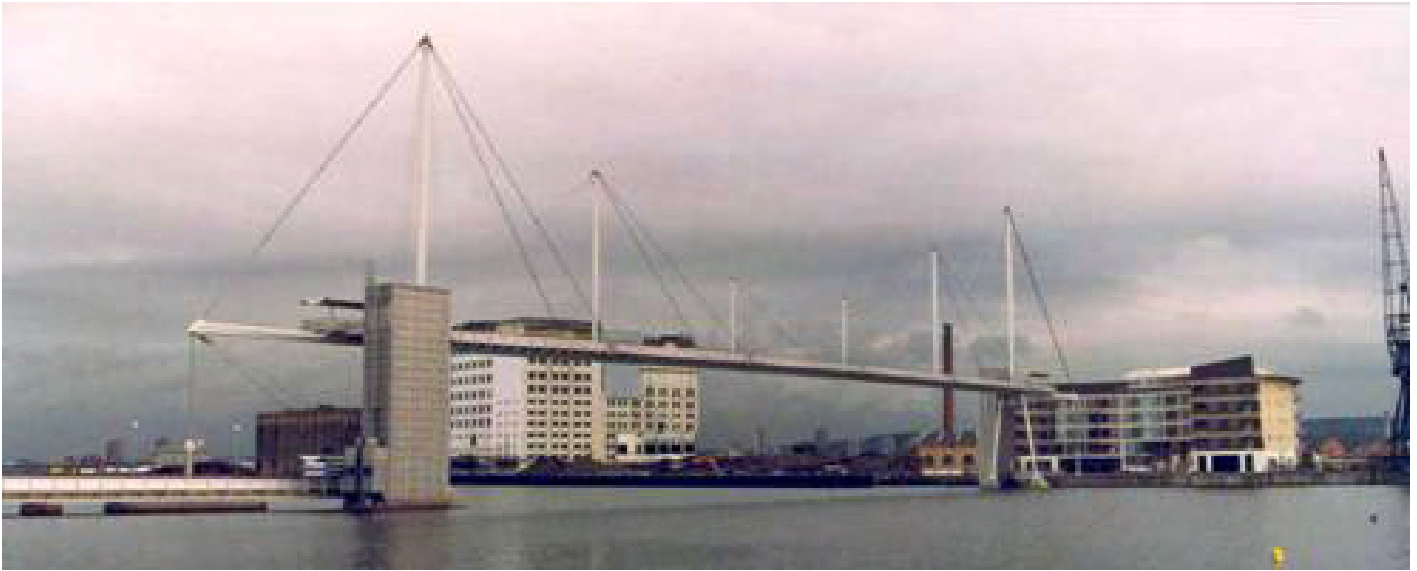
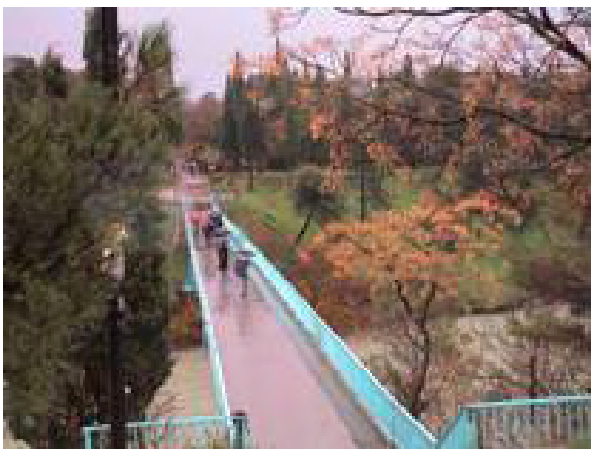
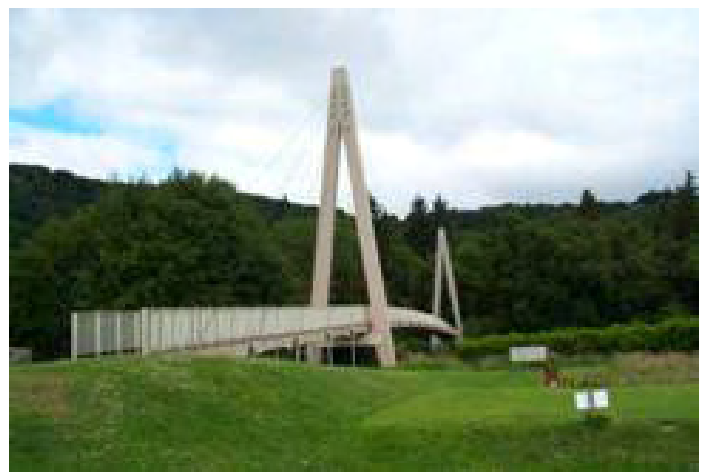
Figure 2 Examples of lightweight footbridges studied with experimental and analytical methods by Sheffield VES
